## Diagnosis and management of commonly encountered problems with cemented implant crowns

BY MICHAEL DANESH-MEYER, BDS, MDS (PERIO)

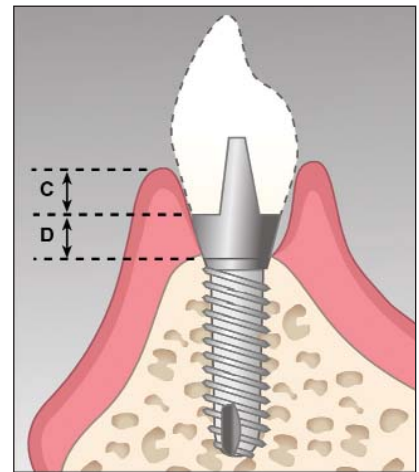
*Diagram 1b. This diagram shows the same clinical situation as in the previous diagram but with a more favourable position of the crown/abutment interface. C = 3mm and D = 3mm. This provides better access to the crown margin to remove excess cement.*

between the dental laboratory technician and the clinician is important and the selection of an abutment with an appropriate shoulder height is critical (Diagrams 1a and 1b).

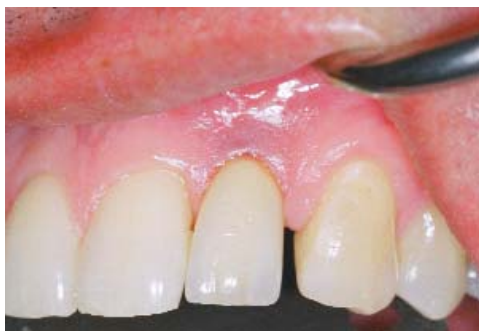
Figure 2. Marginal inflammation resulting from deep subgingival excess cement associated with the implant crown on the 22. Note the bluish tinge above the 22 and the thin gingival biotype in this patient.

found. The tissues will often appear red, oedematous and there may be some gingival exudate from the gingival sulcus (Figures 2 and 3). Occasionally, patients may complain of slight discomfort of the gingival tissues around the implant, although typically these areas are asymptomatic. The acute inflammation associated with the presence of excess subgingival cement can also lead to crestal bone loss. It is therefore imperative that this problem be identified and treated in a timely fashion so as not to jeopardise the long-term health of the implant. If excess cement is removed early (within the first 3-4 months post restoration, it is possible to see reversal of crestal changes radiographically).

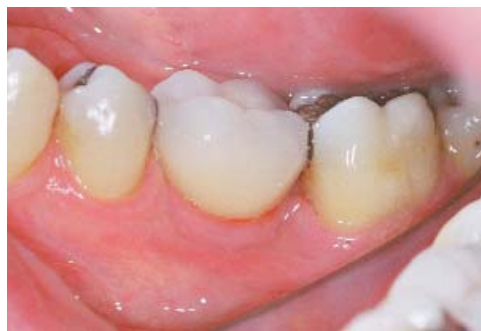
Figure 3. A lower implant supported molar crown presents with significant marginal inflammation 4 months following crown cementation. Excess subgingival cement was subsequently removed from the buccal aspect.

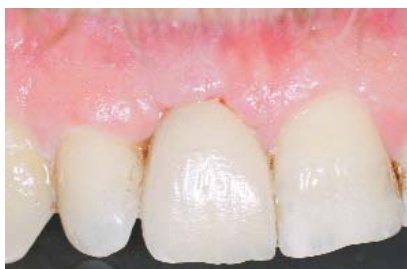
Figure 4. Implant supported crown in the 11 position. Note swelling in the peri-implant tissues at 4 months post crown placement.

Removal of excess subgingival cement involves anaesthetising the peri-implant tissues with local anaesthetic and then using a periodontal curette to carefully negotiate the sulcus until the tip of the instrument makes contact with the cement. One should aim to get the tip of the instrument below the deposit so that a coronal sweeping action will dislodge the cement and remove it from the sulcus (Figures 4-6). In most cases, the tissues around the

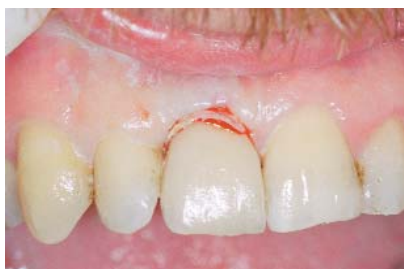
Figure 5. With the use of local anaesthetic and fine periodontal curette, excess crown cement is carefully removed.

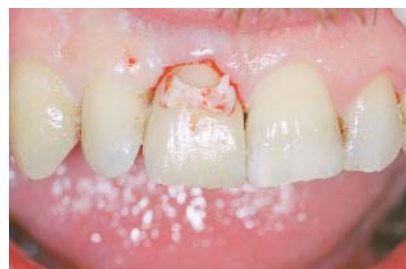
Figure 6. Larger pieces of excess cement are removed from the peri-implant sulcus.

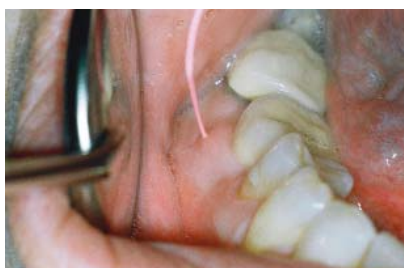
Figure 7. Sometimes, infection caused by retained excess crown cement can cause a gingival abscess, such as shown here on the buccal of the 46 implant. A gutta percha point is used to track the origins of the infection. This can be left in place when taking a radiograph and can therefore help pinpoint the origins of the infection.

sues. Furthermore, care should be taken to minimise scratching the implant abutment surface during removal of the subgingival cement. When possible, plastic implant scalers should be used, however, these will often be insufficient to remove adherent excess cement. Fine tipped periodontal curettes such as a mini after-5 or similar, used judiciously, will often be a better alternative (Figures 7 and 8).

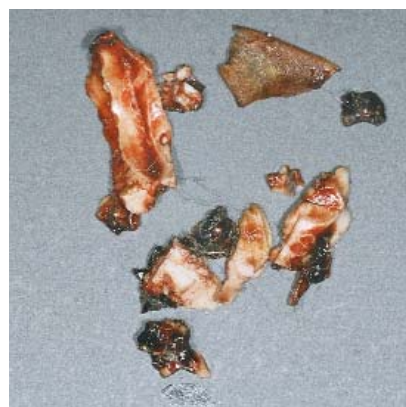
Figure 8. Following careful subgingival debridement, numerous pieces of excess crown cement were removed from around the 46.

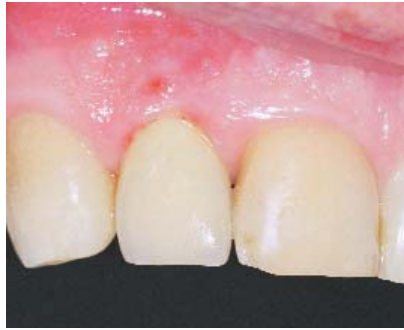
Figure 10. Small labial fenestration or sinus tract resulting from incomplete seating of the crown on the implant abutment in the 12 position.

Incomplete seating of the crown on the abutment creates a subgingival 'step' or gap which will be plaque retentive and lead to chronic inflammation of the peri-implant tissues (Figure 9). This can potentially lead to instability of the marginal gingival tissues and in cases with a thin biotype lead to recession or small fenestrations within the peri-implant tissues (Figure 10).

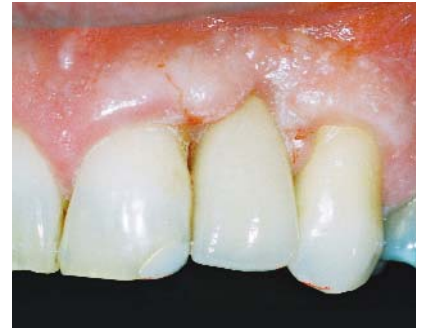
Figure 11. Incomplete seating of the final implant abutment on the 22 implant. Note the marked soft tissue swelling and inflammation around the 22 and adjacent teeth.

Failure to properly seat the definitive implant abutment onto the implant can in turn lead to difficulties with seating of the crown. It can also increase the risk of loosening of the abutment screw and lead to chronic inflammation of the peri-implant tissues (Figures 11 and 12).
